TEST REPORT

Ind. Ser. No. : 13-06-NEF-019
 Applicant : HE ZHEN TECHNOLOGY CO, LTD
 Address : 488,Zhong Zheng Road, Zhong He City,Taipei
 : Conty Taiwan
 Products : Camera(Bus used)
 Model : C01-814
 Quantity : 2set
 Date of Receipt : 2013 / 6 / 11
 Date of Testing : 2013 / 6 / 11 ~ 2013 / 6 / 20
 Test specification : IEC60529 Edition 2.1 2001-02
 : Electronics Testing Center, Taiwan – Southern Taiwan
 Inspection Site : Industry Service Department
 : (TAF Certification No:1161)
 Ambient Environment : IP6X Temp. 26 ± 1 °C , R.H. 49 ± 2 %
 : IPX8 Temp. 28 ± 1 °C , R.H. 60 ± 2 %
 Testing Item : IP68
 Test condition : See the following sheets
 Test result : PASS

Testing Item: IP68

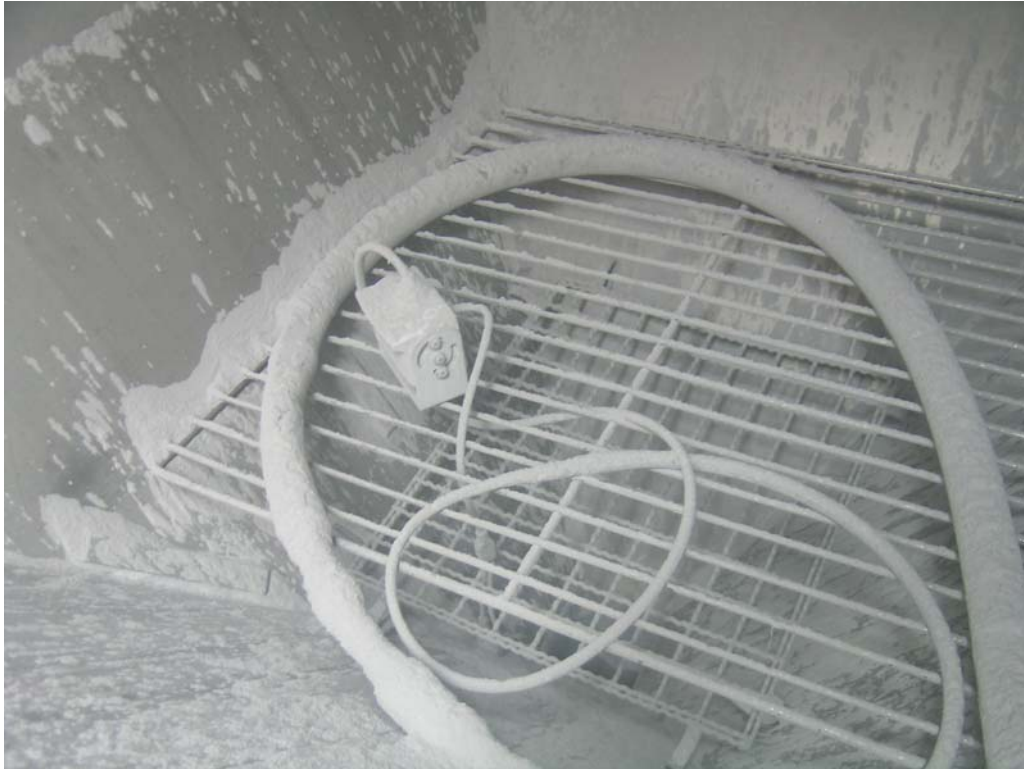
Camera(Bus used) : IP6X Test

Request/Experiment	Results	Remark
Accordance with IEC60529 13.1, 13.4 and 13.6 test. The protection is satisfactory if no deposit of dust is observable inside the enclosure at the end of the test.	There is no trace of dust inside.	IP6X
After testing in accordance with appropriate requirements of IEC60529 14.1,14.2.8 and 14.3	No ingress of water was found inside.	IPX8
